FACTORY TECH TALK

Landing gear mounting frame failure

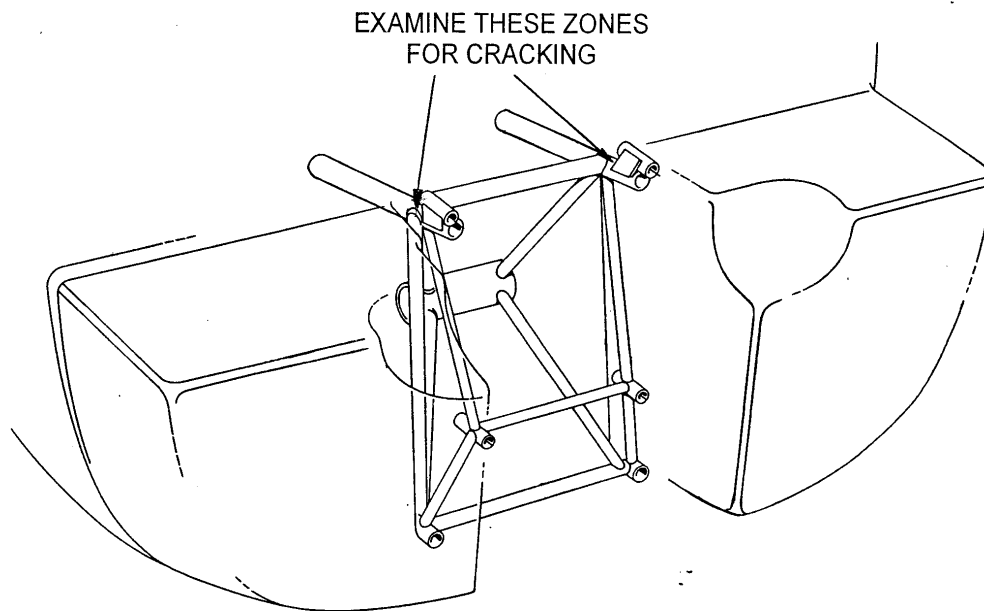
There has been a report of the failure of a landing gear mounting frame. The two upper tubes that the engine mounting frame / ring mount attach to were found to have failed.

Please inspect carefully for cracking of the two tubes on which the smaller diameter mounting tubes are welded to as indicated in the illustration, especially if the aircraft has experienced a heavy landing. Cracking would commence on the upper portion of the tube, so inspection should be straightforward.

We are investigating this issue more thoroughly so we would be grateful to be informed of any cracks found on other mounts.
