# Tailplane mass balance arm replacement

<b>Classification:</b>	This modification has been classified as mandatory by the PFA (UK).
<b>Applicability:</b>	All Europas delivered before February 2005
<b>Compliance:</b>	Aircraft with serial numbers shown in the Appendix, or those which have suffered a heavy landing or ground loop - within the next 5 flying hours, or before the next annual Permit renewal, whichever is the sooner. All other Europas - within the next 25 flying hours or the next annual Permit renewal, whichever is the sooner.

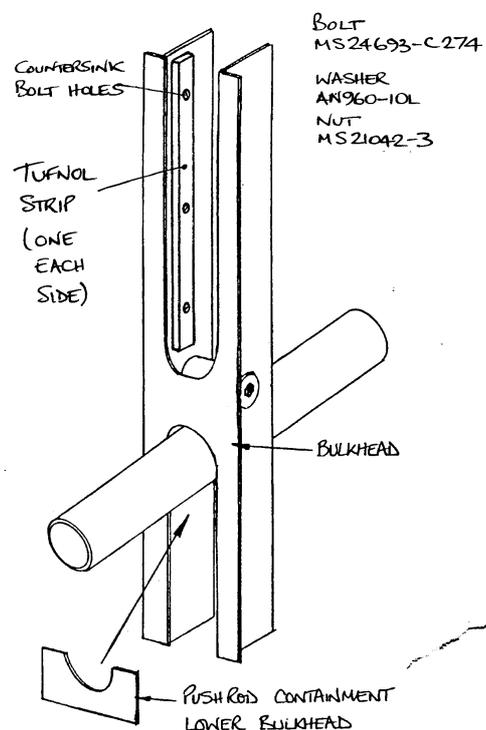
Fig 3. Position of guide strips.

The diameter of the mass balance weights is 50mm, and the nominal clearance is 2mm each side - check that the clearance achieved is between 1mm and 4mm each side.

Check also that the movement of the weights runs parallel to the guide strips and that they are not rubbing. If the pitch control stop structure is not mounted parallel to the mass balance arm movement, the fixing brackets will require removal and re-making. Refer to the chapter Tailplane Mass Balance and Control Stop in the build manual.

With the mass balance arm out of the way, install the low friction guide strips, one to each of the inside faces of the pitch control stop support structure - see figure 3 overleaf.

Position the guide strips such that they cover the movement of the mass balance weights from the bottom stop to the top stop. Drill through the support structure with a 4.8mm drill and bolt in position with the countersunk screws, AN960-10L washers, and MS21042-3 stiffnuts.

If the weights are rubbing against a guide strip, it is permissible to reduce the thickness of the strip, down to the depth of the bolt head only, provided that the clearance limits are maintained by adding a spacer behind the opposite guide strip. Alternatively, cables may be used, as in the original installation, to centre the end of the arm. To provide a means of attaching the cables to the front of the arm, a part that fits in place of the TP18D sleeve is available on request. This part, TP18F, is a sleeve with added lugs positioned such that, with the use of AN115-21 shackles, the original cable should be able to be used. To fine tune adjustment of cable length, cable tensioners, such as turnbuckles, will be required. If you do not re-use the cables, they must be cut off from the torque tube and discarded.

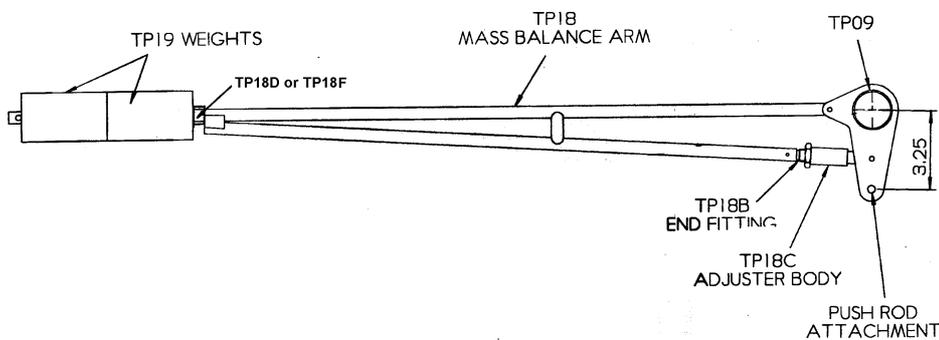
Fig 4. General arrangement of mass balance arm assembly.

A failure of the TP18 tailplane mass balance arm assembly has occurred on an aircraft on the British register which had previously suffered a number of landing mishaps. Whilst this was an isolated occurrence, investigation showed that the assembly needs to be updated. A new design has been produced and tested. This new unit is similar in dimension to the old unit, but is constructed from heavier gauge tubing, with a stronger adjusting mechanism. It has been found unnecessary to include the restraining cables in the new design, provided that low friction guide strips are fitted to the inside faces of the pitch control stop support structure. A general arrangement of the modified arm assembly is shown at figure 4.

Using the preferred method of access connect the new arm assembly to the tailplane torque tube using the existing bolts, washers and nuts. The adjuster TP18C has two flats machined - this will assist in fitting the unit to the hole in TP9. It has been found that it is best to fit the lower bolt first.

Back inside the rear of the fuselage refit the weights onto the end of the mass balance arm and temporarily fit an AN3 sized bolt with its head cut off into the hole for the roll pin to stop the weights from sliding off the end. Ensure that the weights are up against the temporary bolt and check for mass balance. (Note that the balance should be checked with the tailplane operating controls connected). Alter the amount of weight, if required, to achieve best neutral balance. To reduce the balancing mass drill small holes in the front weight; in the unlikely event that an increase is needed contact Europa.

Now measure the amount of space between the rearmost weight and the end of the support strut of the mass balance arm. Cut an appropriate length of the sleeve TP18D, remove the weights, install the sleeve, then reinstall the weights and secure them with the 6mm roll pin - if the pin is not a tight fit it must be replaced. Finally, if necessary, adjust the TP18C unit so that the tailplane movement range is between 12° - 13° trailing edge up and 4° - 5° trailing edge down when the weight is in contact with the control stop. The tailplanes are in neutral when the port tailplane is lined up with the fuselage moulding on the port side.
