Undercarriage mounting frame strengthening

Classification: This bulletin, which comprises inspection and modification, has been classified as mandatory by the PFA (UK).

Applicability (Inspection): All Europas (Classic and XS models) fitted with landing gear frames supplied before January 2007.

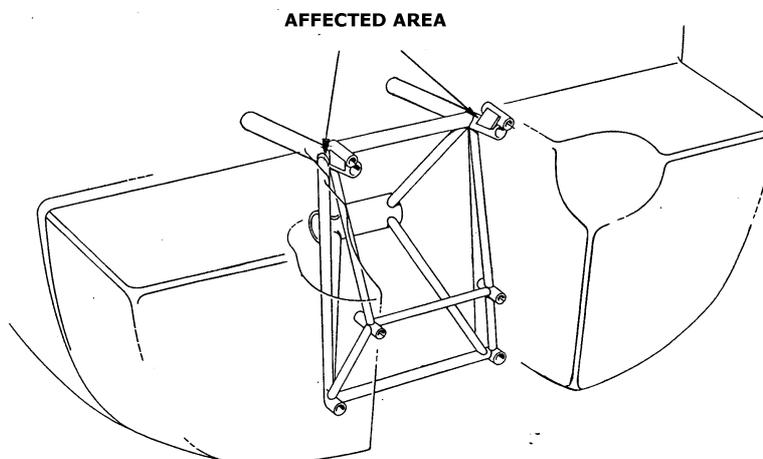
A failure has occurred to the undercarriage mounting frame of a Europa. Examination of the mode of failure has shown that the upper horizontal tubes are insufficiently strong in the area indicated in figure 1.

Fig 1. Affected area of frame.

This is due to the offset distance of the engine frame mounting tubes from the main horizontal upper tubes, resulting in high bending stresses at the welded joint. This modification introduces inserts in the upper tubes which provide extra support to those tubes. The upper tubes require reaming to ensure correct fit of the inserts and to clean away any weld penetration.

Inspect the area affected as shown in figure 1. If any crack is found the aircraft must be grounded immediately and the frame replaced with an upgraded unit from Europa.

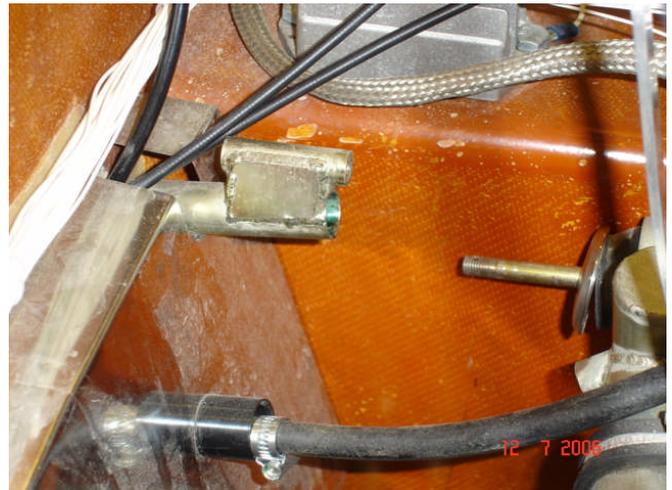
Fig 2. Engine lowered to give access to upper horizontal tube.

Lower the engine approximately 50 - 75 mm (2 - 3") and swing it forward to gain access to the upper horizontal tubes. Figure 2 shows the engine lowered to enable the tube reaming to take place.

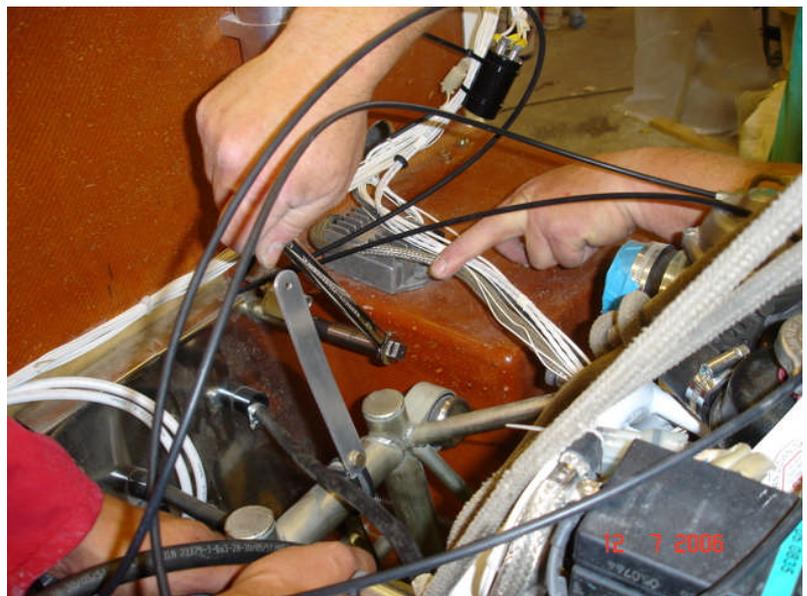
Fig 3. Reaming tube using a spanner (wrench) to drive the reamer.

Using the 16.5mm reamer, ream out the two upper horizontal tubes as far as possible - the end of the reamer will contact the most forward of the bolts connecting the frame to the tunnel. There is not much metal to remove, and it will normally be possible to carry out this operation dry. You may encounter resistance where the other tubes are welded - keep a firm pressure on the end of the reamer to ensure it keeps cutting. Figure 3 shows the reaming being carried out.

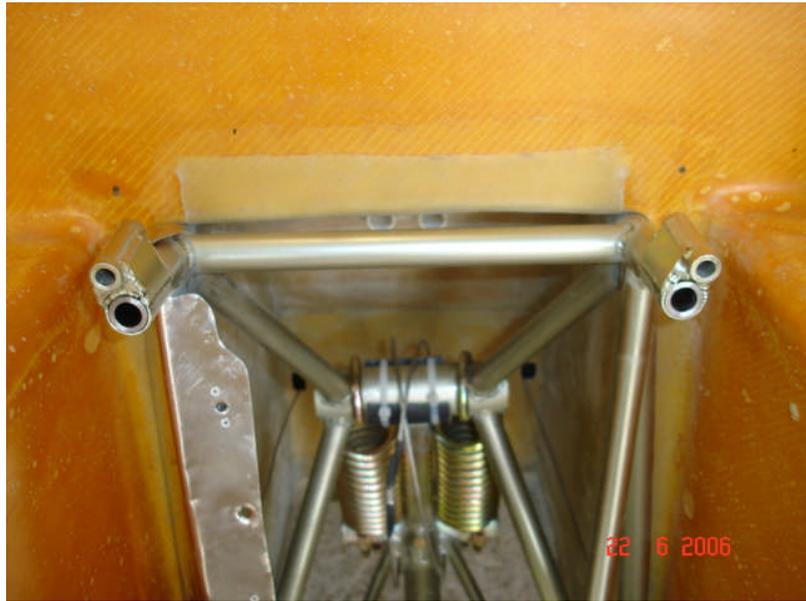
Fig 4. Tube inserts in place.

Coat the inserts, part number LG31, with a light film of ACF 50, which will act as a protectant against corrosion. Insert the tubes - they will probably need a light tap to fit them. Figure 4 shows the tube inserts in place.
