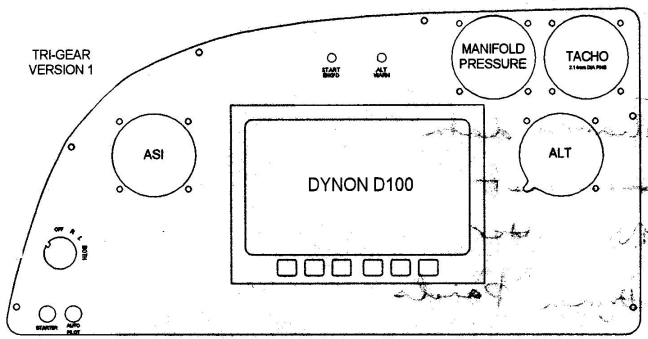
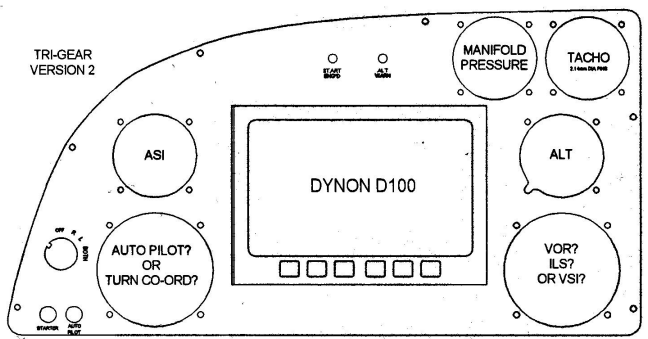
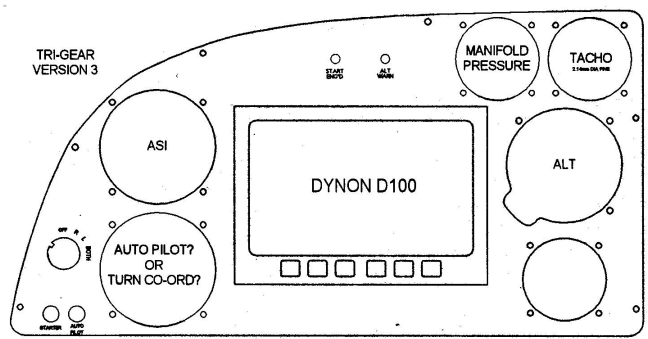
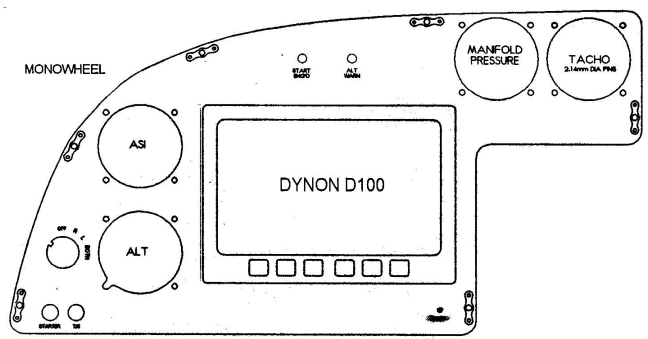
To compliment the existing laser cut instrument panel fascias that accommodate conventional instruments, a new design is being developed based around the new Dynon D100 EFIS unit. The D100 is based on the successful D10 unit. The D10 has a 3.8" screen but the D100 has a 7" screen and only costs about \$200 more. Space constraints result in the panel being equipped with 2-1/4" ASI and Altimeter, leaving room for two 3-1/8" instruments under each respectively. These apertures may be used for a wing leveller and VOR/ILS or even the conventional turn co-ordinator and VSI as back ups, for example. See the illustration.

In concert with the EFIS, the feasibility of laser cut avionics panels are also being investigated to accommodate the AvMap EKP-IV (which has an impressively clear and large display) and the popular Skyforce Skymap II and III GPS moving map units. The size of these units determines that the Com and Transponder units are the 2-1/4" diameter type. There is a choice of two makes of these at least. The portrait orientation of the display shows more information ahead of track, although landscape orientation will fit in the panel. Feedback from anyone interested in these panel designs would be appreciated before a commitment to production is made.

The thought behind the EFIS and GPS units mentioned is that, as all are stand-alone in their operation this results in minimised complexity, and the prices are not unreasonable. There are plenty of other units on the market, but usually at a significantly higher cost. Not to exclude the choice of these other units, a version of both panel fascias is likely to be produced where the central area is blank. See illustrations at the end.
